Manhole Inspection Summary

Manhole # S35WW_004MH

Insp Date: **1/9/07 10:19 AM**

Location Address: **3100 ABELL AVE**

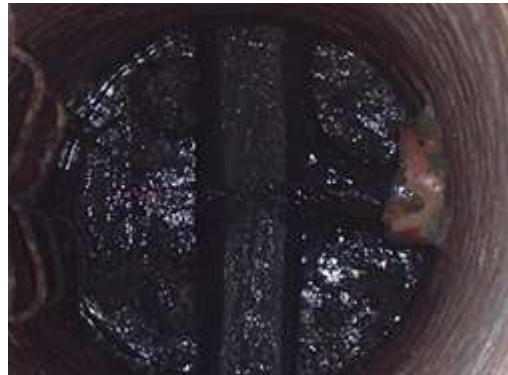
Top View

Corroded steps. Bench debris.

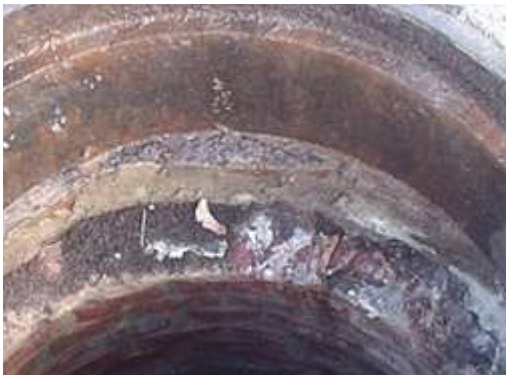
Defect

Frame leaks. Frame offset. Adjustment infiltration.

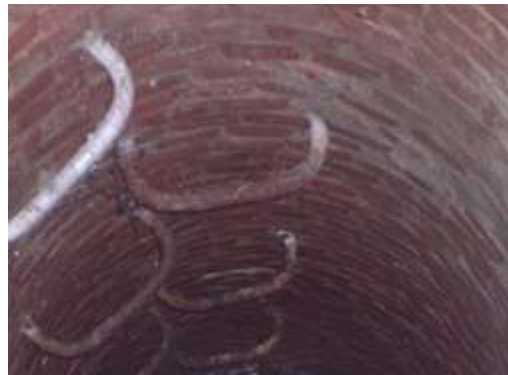
Defect

Corroded steps.

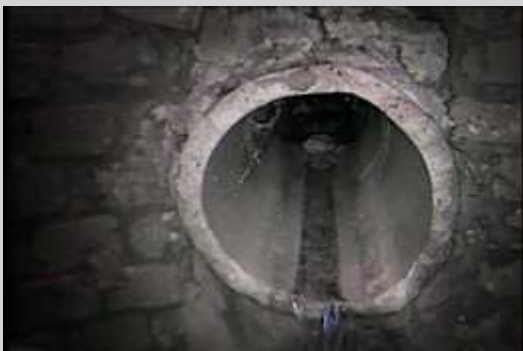
8 in. Circular Gravity Sewer Pipe In @ 3 O'Clock

Infiltration: **Evidence** Pipe Seal Cond: **Cracked**

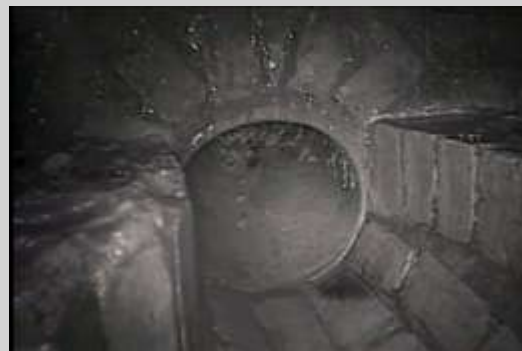
Drop In @ 3 O'Clock

Drop Condition: **Clogged**
